# **AN EVALUATION OF A POTENTIAL BARRIER TO THE UPSTREAM MOVEMENT OF BROOK TROUT IN ROCKY MOUNTAIN NATIONAL PARK, COLORADO**

Technical Report NPS/NRWRD/NRTR-2005/337

January 2004

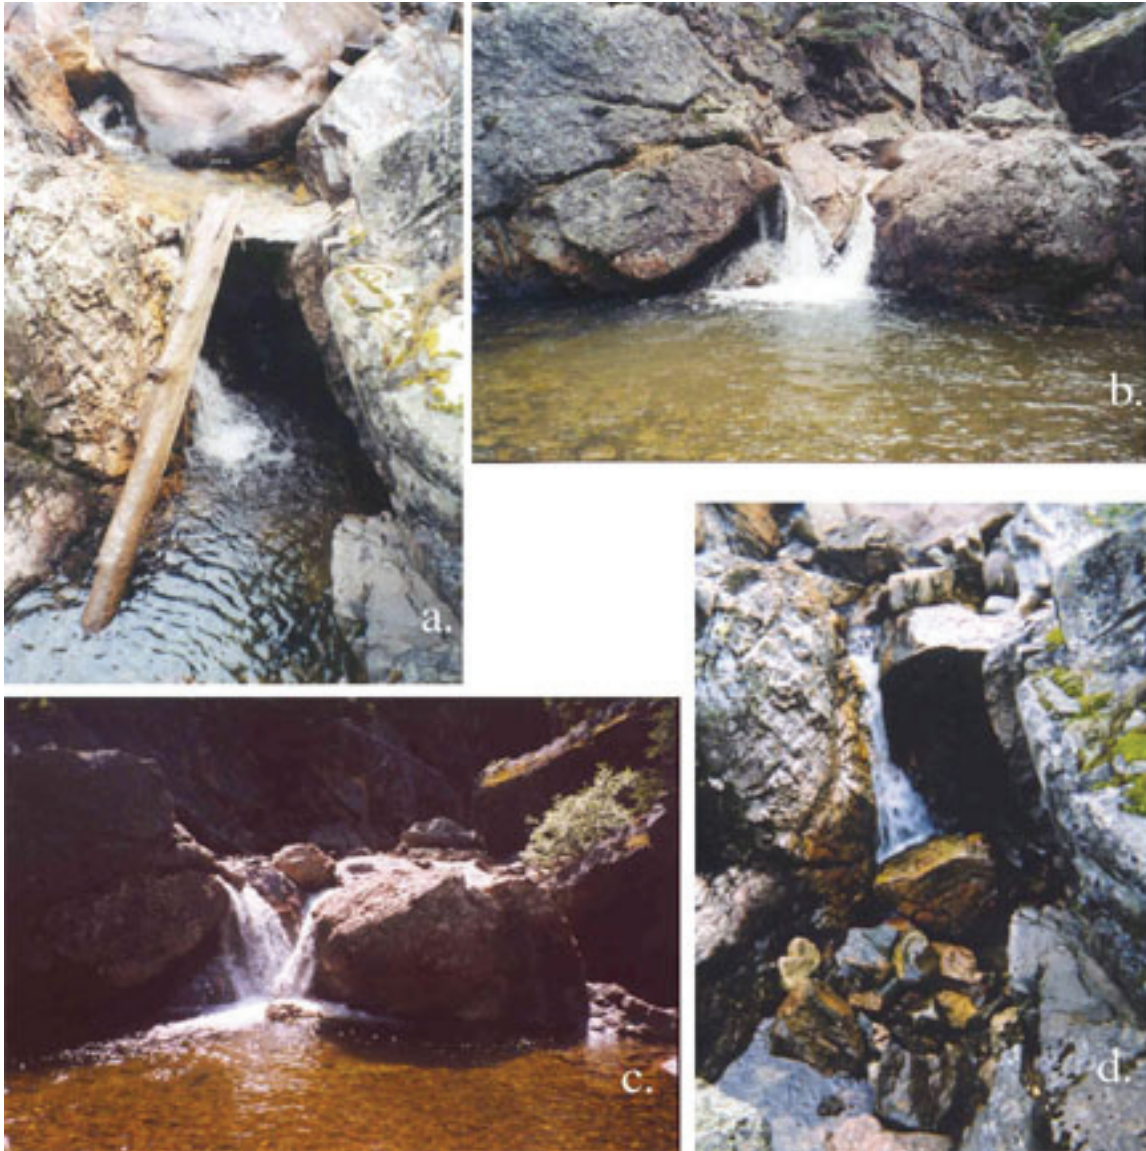
**Figure 2.** Physical appearance of side-chute channel drop (a.) and main-fall channel drop (b.) before modification and main-fall channel drop (c.) and side-chute channel drop (d.) after modification of a natural waterfall on the Big South Fork of the Poudre River, RMNP, CO. Dimensions for “before” were measured on October 12, 2001 when the flow was approximately  $0.10 \text{ m}^3/\text{s}$  (3.7 cfs). Dimensions for “after” were measured on September 28, 2002 when flow was approximately  $0.06 \text{ m}^3/\text{s}$  (2.1 cfs).

Detailed measurements of the stream and waterfall were made on two dates. We measured the waterfall on October 12, 2001 before modifications were completed and also on September 28, 2002 after waterfall modifications. Flows were lower in 2002 than in 2001 ( $0.1 \text{ m}^3/\text{s}$  compared to  $0.06 \text{ m}^3/\text{s}$ ). Modifications to the waterfall were made before we had completed our laboratory-based brook trout jumping evaluations and therefore were based on the combined experience of National Park Service and US Fish and Wildlife Service personnel. The goal of the modification was to make the waterfall impassable to fish by increasing the height while decreasing the plunge pool depth, particularly along the side chute. Specifically, boulders were removed from the tail of the plunge pools to further decrease pool depths and effectively increase vertical waterfall height, the pools above the waterfalls were filled in with rock material to restrict water movement and create a potential water velocity barrier in the landing area, and rocks were dropped into the plunge pools to further decrease the plunge pool depths, create more aerated water conditions below the falls, and increase the downstream distance of the standing wave from the base of the falls to make conditions less optimal for jumping fish (Figure 2).

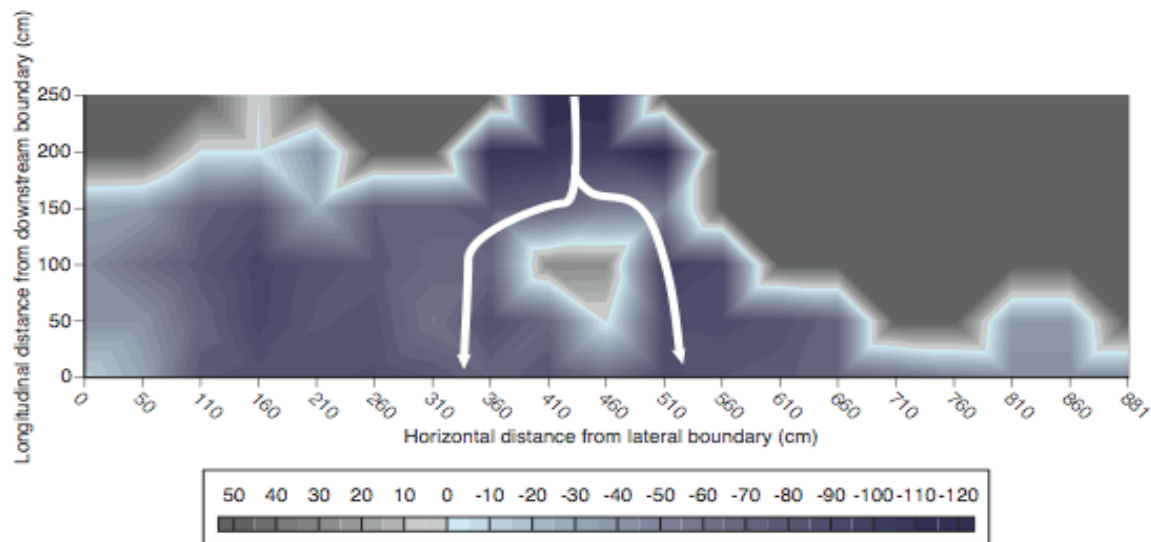
**Figure 3.** Contour map of the plunge pool located downstream of the main-falls after modification. Dimensions were measured on September 28, 2002 when the flow was 0.058 m<sup>3</sup>/s (2.1 cfs). Arrows indicate flow direction. The color scale indicates water depth (cm) from the surface (0 cm) to the deepest point of the pool (-50 cm).

The maximum depth of the plunge pool on the main falls was decreased from 1.50-m to 1.00-m (measured in front of the splash zone of the falls) after modifications<sup>3</sup>. The depth at the tail of the post-modified plunge pool was 0.17-m, giving a residual depth of 0.83 m. Prior to modifications, we were unable to make more detailed measurements of the rest of the main fall plunge pool because depths were too great. However, we measured the post-modified plunge pool in more detail in order to develop a contour map (Figure 3). The minimum distance from the pool surface to the waterfall crest was measured as 2.0-m before modifications and was measured as 1.9-m after modifications. The lower vertical height measured in 2002 was probably a result of the lower flows during this year, which decreased the height of the crest of the main falls.

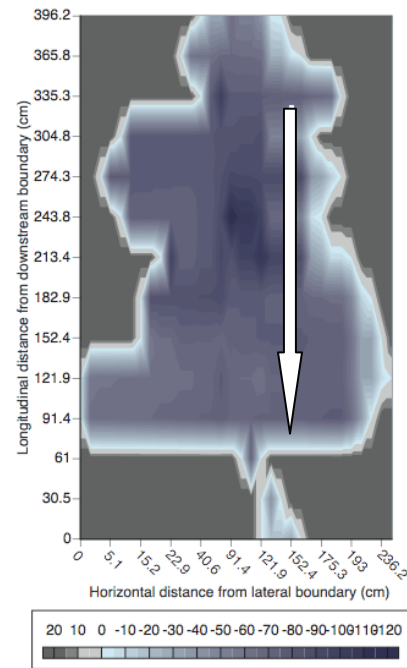
**Figure 4.** Contour map of the plunge pool located downstream of the side-channel portion of the barrier **before modification**.

Dimensions were measured on October 12, 2001 when the flow was  $0.1 \text{ m}^3/\text{s}$  (3.7 cfs). Arrow indicates flow direction. The color scale indicates water depth (cm) from the surface (0 cm) to the deepest point of the pool (-50 cm).

After modifications, the maximum plunge pool depth of the side-channel falls decreased from 1.17-m to 0.36-m and the portion of the pool under 0.10 m in depth increased greatly (see Figures 4 and 5). The minimum distance from the pool surface to the waterfall crest increased from 1.17-m to 1.38-m and the deepest portion of the upper pool was reduced from approximately 1.1-m 0.3-m (see Figures 6 and 7).

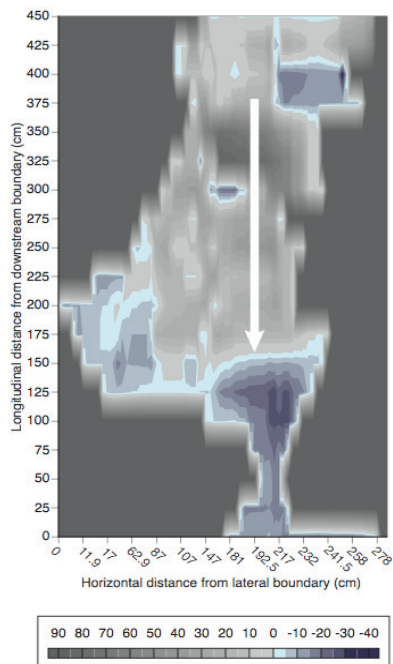
**Figure 5.** Contour map of the plunge pool located downstream of the side-channel portion of the barrier **after modification**. Dimensions were measured on September 28, 2002 when the flow was  $0.058 \text{ m}^3/\text{s}$  (2.1 cfs). Arrow indicates flow direction. The color scale indicates water depth (cm) from the surface (0 cm) to the deepest point of the pool (-50 cm).

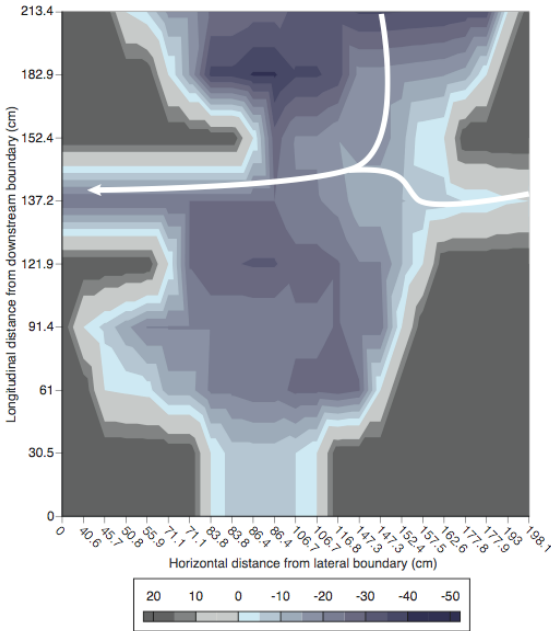
**Figure 6.** Contour map of the upper pool located upstream of the side-channel portion of the barrier **before modification**. Dimensions were measured on October 12, 2001 when the flow was  $0.1 \text{ m}^3/\text{s}$  (3.7 cfs). Arrows indicate direction of flow. The color scale indicates water depth (cm) from the surface (0 cm) to the deepest point of the pool (-50 cm).

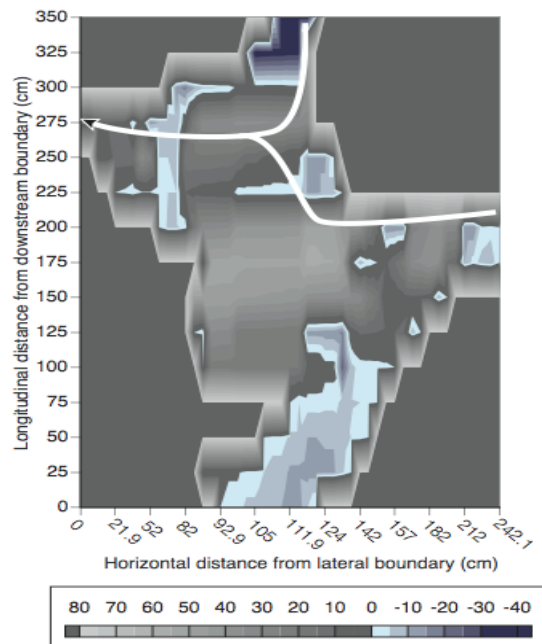
**Figure 7.** Contour map of the upper pool located upstream of the side-channel portion of the barrier **after modification**. Dimensions were measured on September 28, 2002 when the flow was  $0.058 \text{ m}^3/\text{s}$  (2.1 cfs). Arrows indicate direction of flow. The color scale indicates water depth (cm) from the surface (0 cm) to the deepest point of the pool (-50 cm).

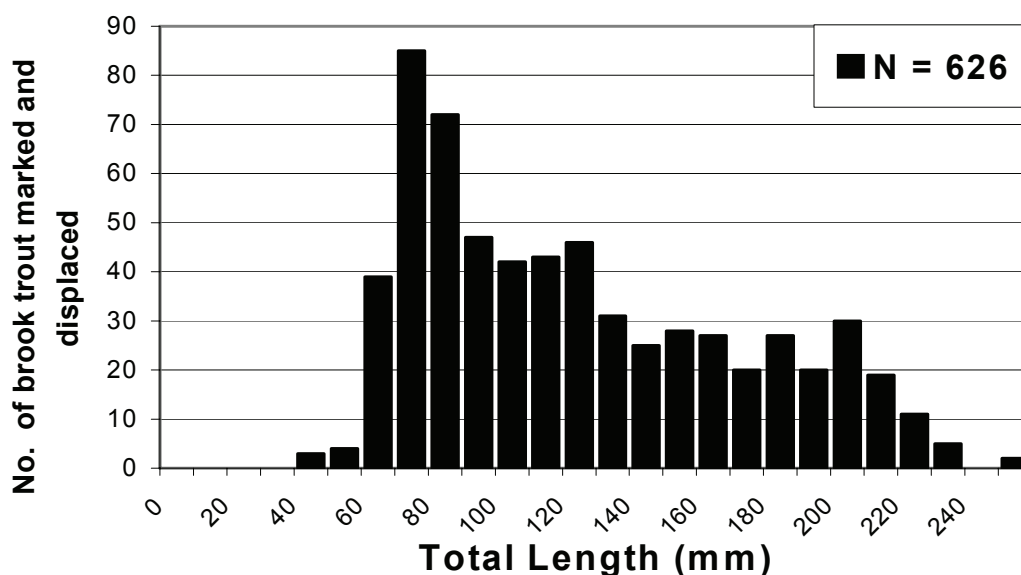
**Figure 8.** Size distribution of 626 brook trout marked and displaced below the waterfall from 2001 and 2002. None of these fish were recaptured above the waterfall during our 2002 surveys, but 3 fish (TL: 96, 166, and 177 mm) were recaptured during surveys in 2003.

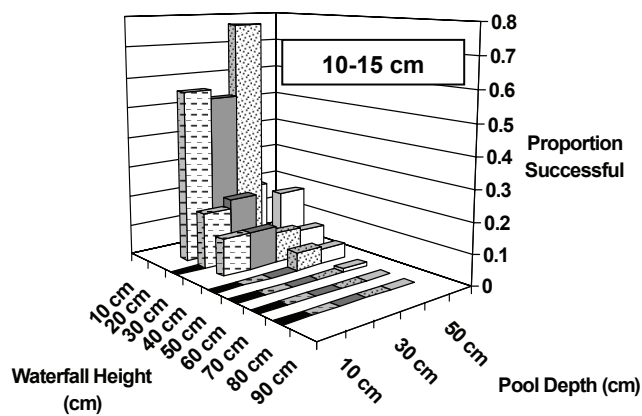
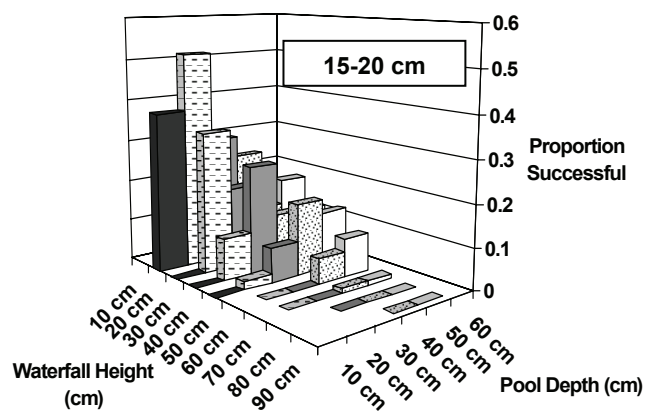
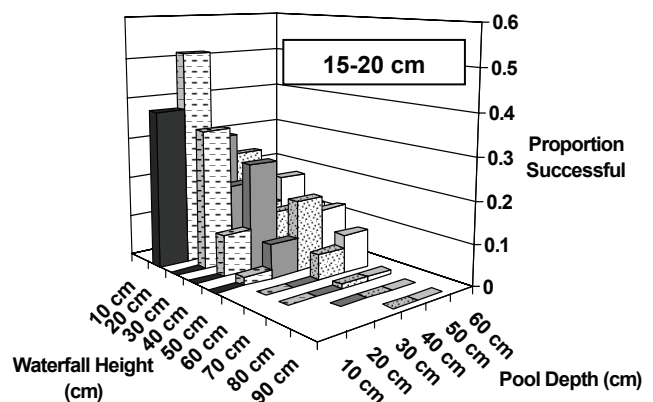
**Figure 9 (A, B, C).** Results of laboratory tests of Brook trout jumping over a waterfall of fixed height. Proportion successful (Z-axis); height (Y-axis, cm) and fixed pool depth (X-axis, cm) for fish in the 10-15 cm TL (Figure 9a), 15-20 cm TL (Figure 9b), and 20+ cm TL (Figure 9c) size classes. Blank spaces represent height  $\times$  depth combinations for which no data were collected.

No fish longer than 20 cm TL were recaptured above the falls. Finding *smaller* fish upstream is contradictory to the findings from our laboratory tests of brook trout jumping behavior (Figures 9a-9c) and model predictions (Figure 10). These results showed that the larger fish (20+ cm TL) should have had the greatest probability of jumping over the waterfalls, as fish  $\leq$  15 cm TL only jumped a maximum height of 63.5 cm and fish  $\geq$  15 cm jumped a maximum height of 73.5 cm under laboratory conditions. Some degradation of jumping and swimming performance is expected under laboratory conditions, particularly when hatchery-reared fish are used (Duthie 1987), but it is unlikely that this is the principal reason for the gross disparity between the laboratory and field results. One explanation is that it is unlikely the recaptured fish ascended the falls by jumping from plunge pools over the falls in one jump. The fish that were found upstream may have been small enough to use intermediate pools located in the face of the falls (particularly prevalent on the side-chute) to ascend the falls in smaller steps. Other possible

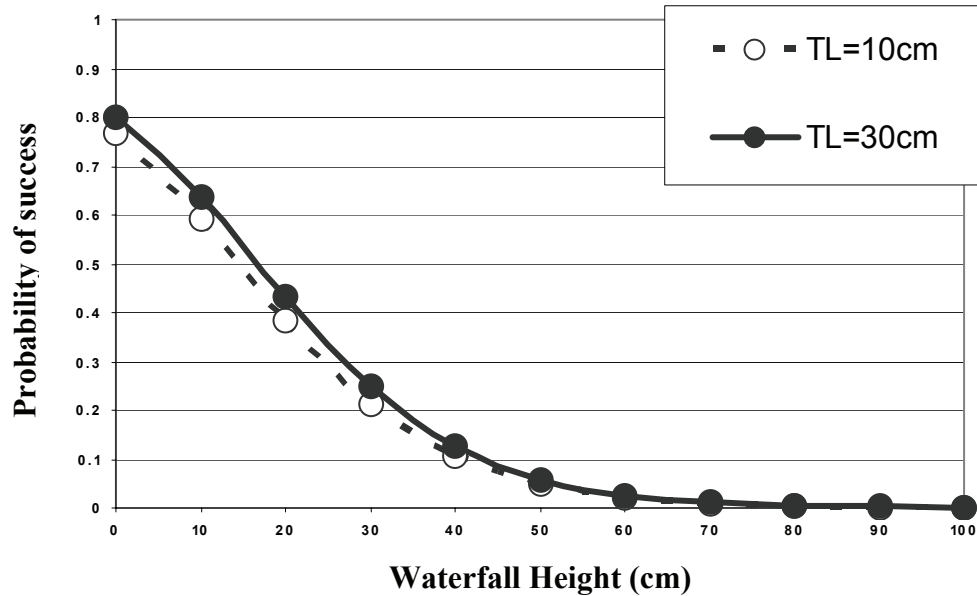
**Figure 10.** Model results using the best AIC<sub>c</sub> model for a healthy, 10 cm and 30 cm total length brook trout jumping over a waterfall for a fixed pool depth of 60 cm (maximum depth tested).

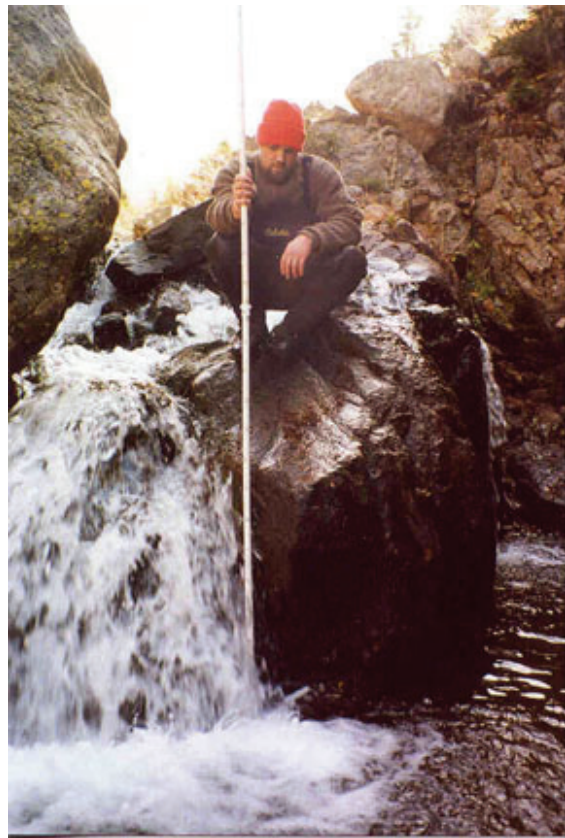
**Figure 11.** Waterfall on Hague Creek, a tributary of the Big South Fork of the Poudre River, RMNP, CO. Dimensions were measured on September 29, 2002 at flows of 0.07 m<sup>3</sup>/s (2.4 cfs). The main falls (shown) are 1.1 m in height. The splash from the side-channel falls can be seen in the background (right).

The next potential barrier was located along the uppermost portion of Hague Creek, less than 300 m below timberline (40° 30.220' N; 105° 40.874' W). The waterfall is located directly downstream from a small meadow in a bedrock-constrained segment of the stream. The stream cuts through a 200-m long canyon section with steep (approximately 20 m high) walls. The flow directly upstream of the site (40° 30.202' N; 105° 40.863' W) was 0.07 m<sup>3</sup>/s on September 29, 2002. The elevation (measured by a Garmin GPS) at the site was 3159 m. The waterfall had a main falls where most of the water was flowing, and a side-channel falls where a smaller amount of water was flowing. The minimum vertical distance from the surface of the plunge pool to the crest of the main falls was 1.1 m; the minimum vertical distance of the side chute falls was 1.3 m (Figure 11). The plunge pool beneath the waterfall had a maximum depth of 0.8-m, was 6.1-m long, and 4.1-m wide, but the water depth directly below the waterfall was only 0.4 m. The depth of the pool beneath the side channel falls was 0.6 m. The pool above the falls had a maximum depth of 0.53 m.
